Detection of a Defect on the Back of a Pipe by Noncontact Remote Measurements

Hayashi, Takahiro. Detection of a Defect on the Back of a Pipe by Noncontact Remote Measurements. Journal of Pressure Vessel Technology 2018, 140(6): 061401.

Detection of a defect on the back of a pipe by non-contact remote measurements

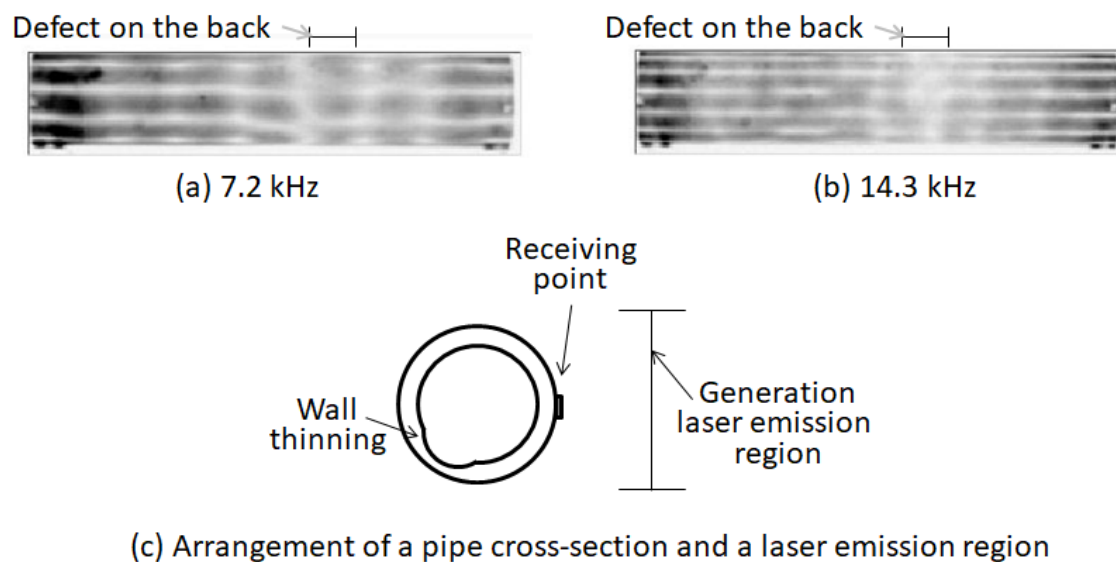
Fig. 12. Sum of distributions of frequency spectrum peak for left and right receiving positions when wall thinning is located at $\theta=235^\circ$.

Figures 12 (a) and (b) are the averaged distributions at 7.2 kHz and 14.3 kHz, respectively, when the defect is located at $\theta = 235^\circ$. These figures were obtained using the same procedures used to obtain Fig. 10 (c) and Fig. 11 (c); only the circumferential locations of the wall thinning were different. These figures show similar tendencies as Fig. 10 (c) and Fig. 11 (c); the vertical patterns are symmetrically distributed from the defect area at 7.2 kHz, and a small intensity region appears at the defect area at 14.3 kHz.
